## **Report on the Repair of the 4" Mainline Near 4761 Highway 31 – March 1, 2026**

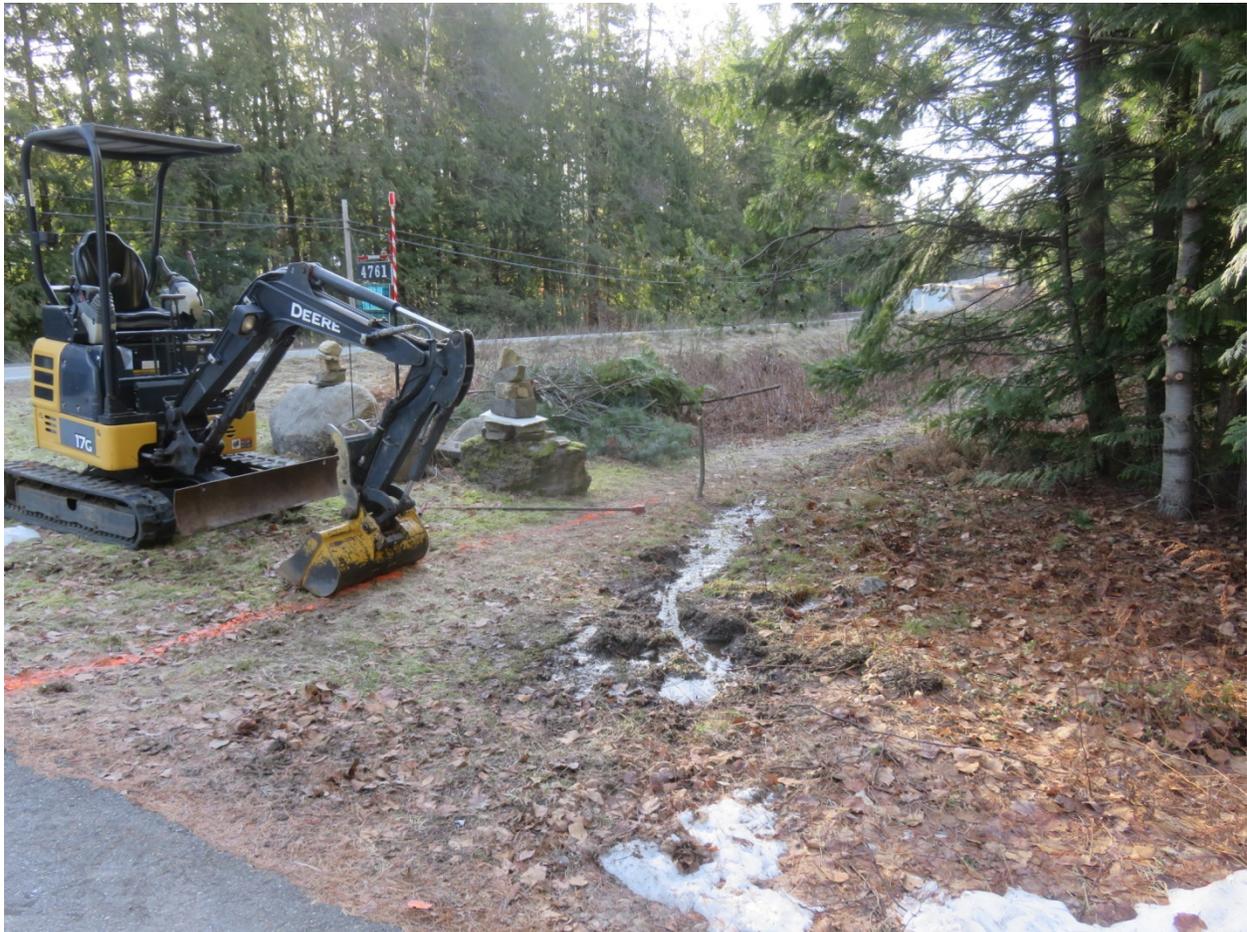
In the days leading up to the work, KIN marked the location of their fibre optic cable. FCID located its line and acquired repair materials.

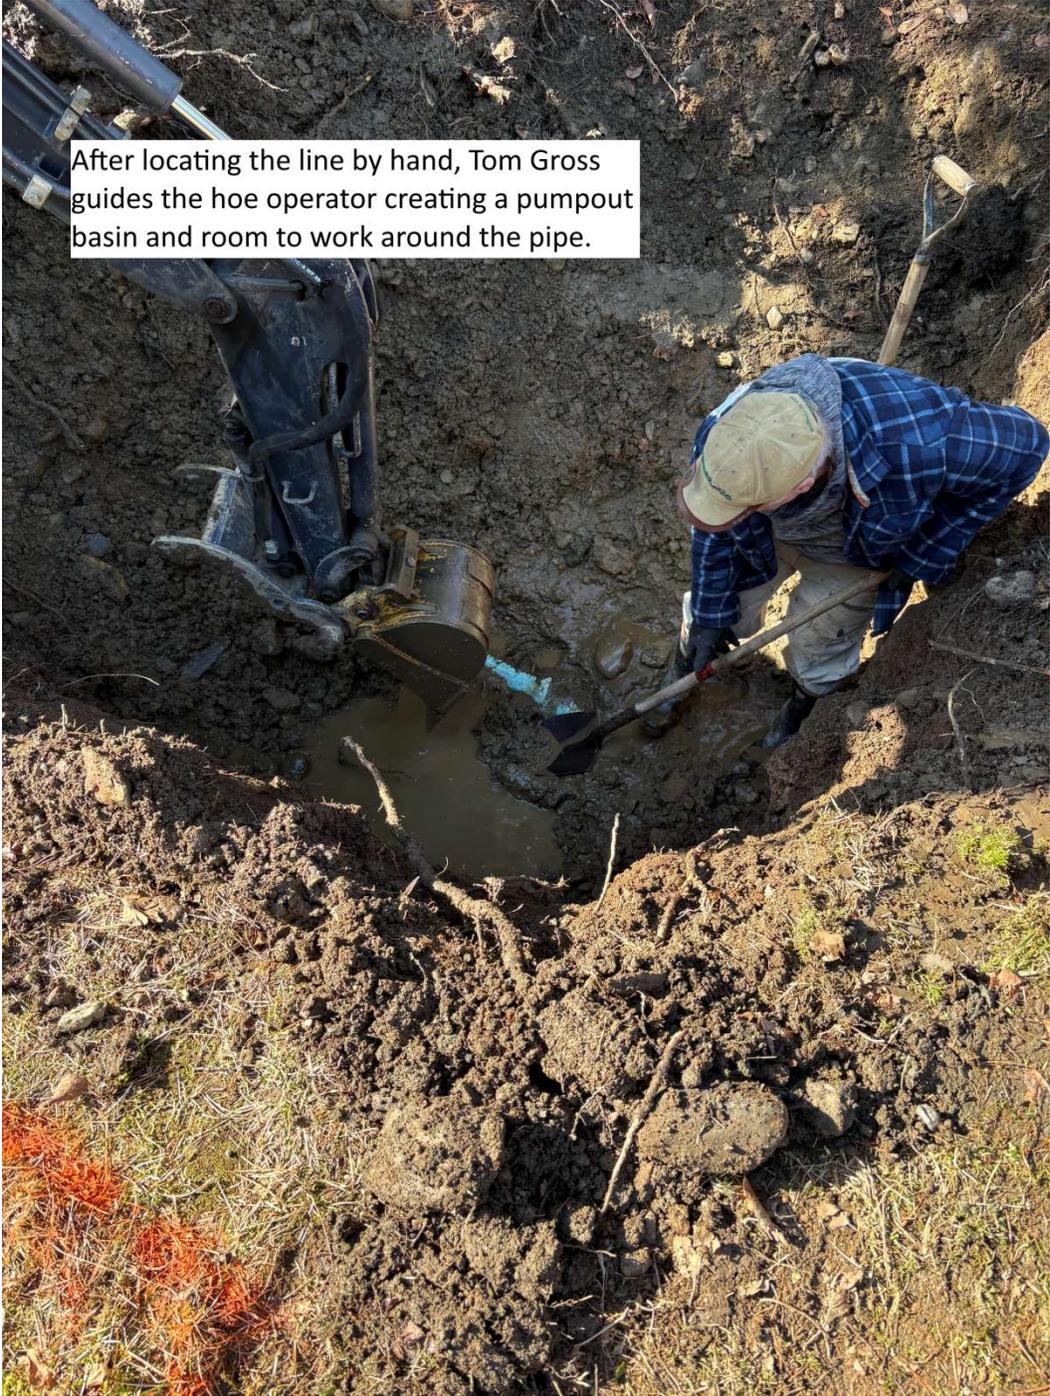
Digging began in water saturated soil. It was muddy. The mainline was found approximately 3 ft west of where line location indicated. The lack of precision was attributed to the presence of another below grade facility (Kin tracer).

After locating the line by hand, Tom Gross guides the hoe operator creating a pumpout basin and room to work around the pipe.

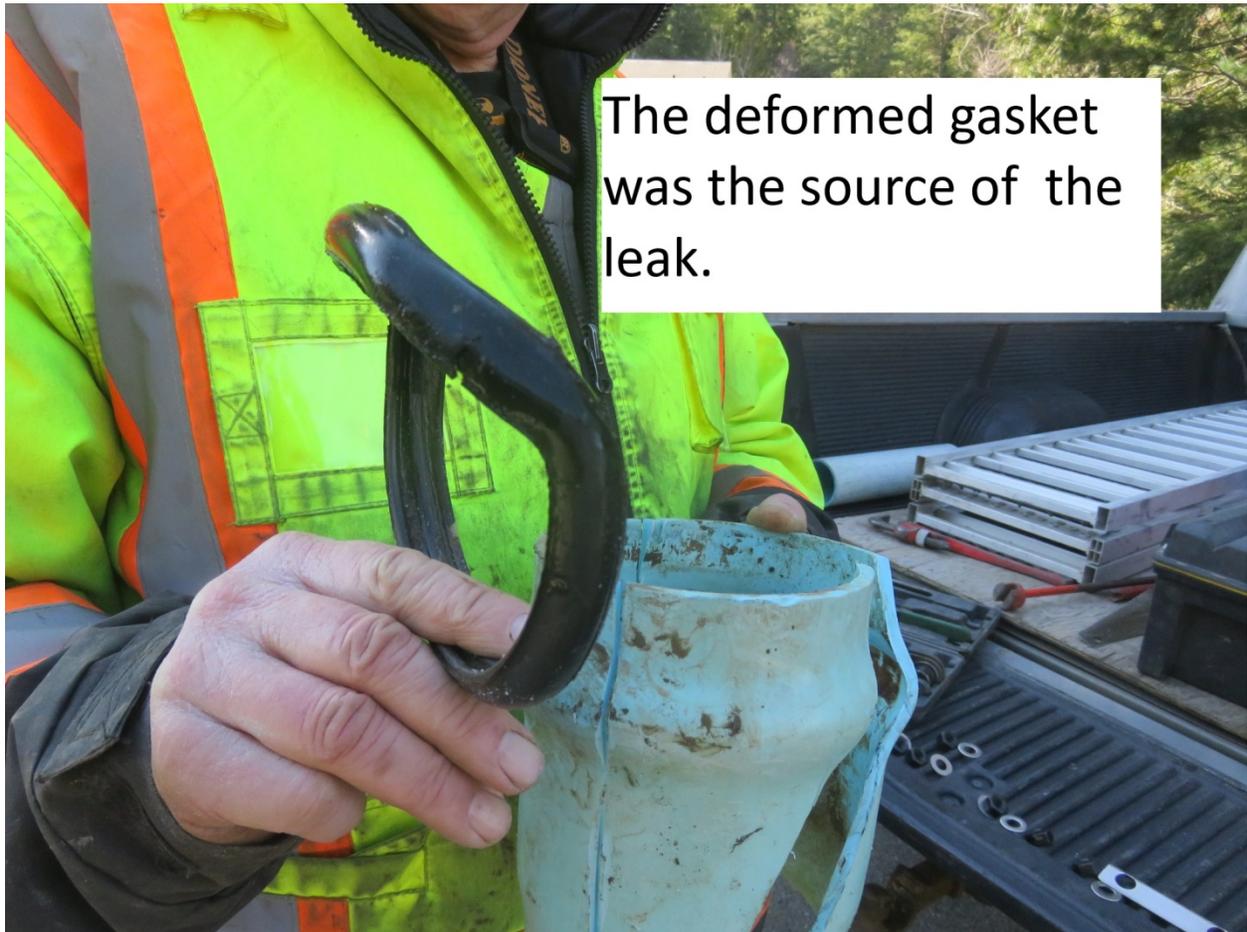
The bell was cut off the leaking joint. The twisted gasket was removed. It is likely the joint leaked from day it was put in service.

The deformed gasket was the source of the leak.

A 12" long "clamp on" repair sleeve was installed over the 1" gap between the pipe ends.

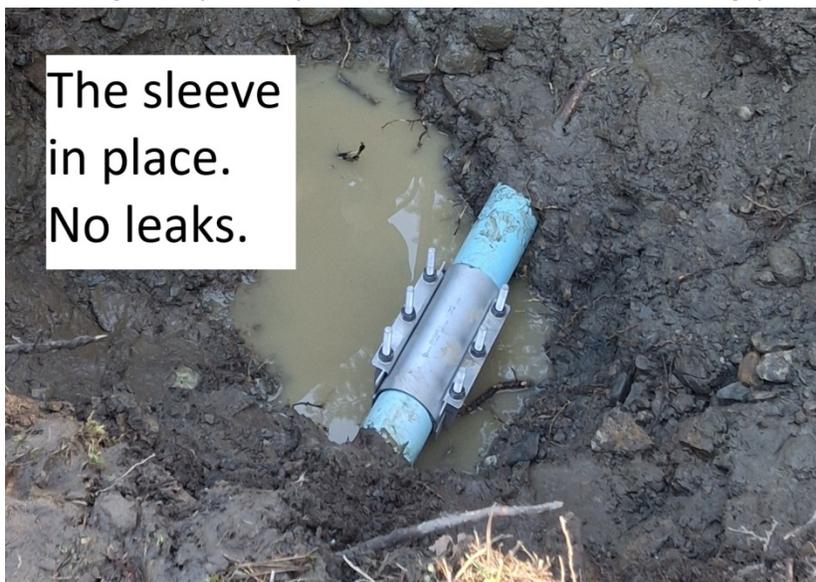
The sleeve in place. No leaks.

The excavation was left open overnight to confirm tightness.

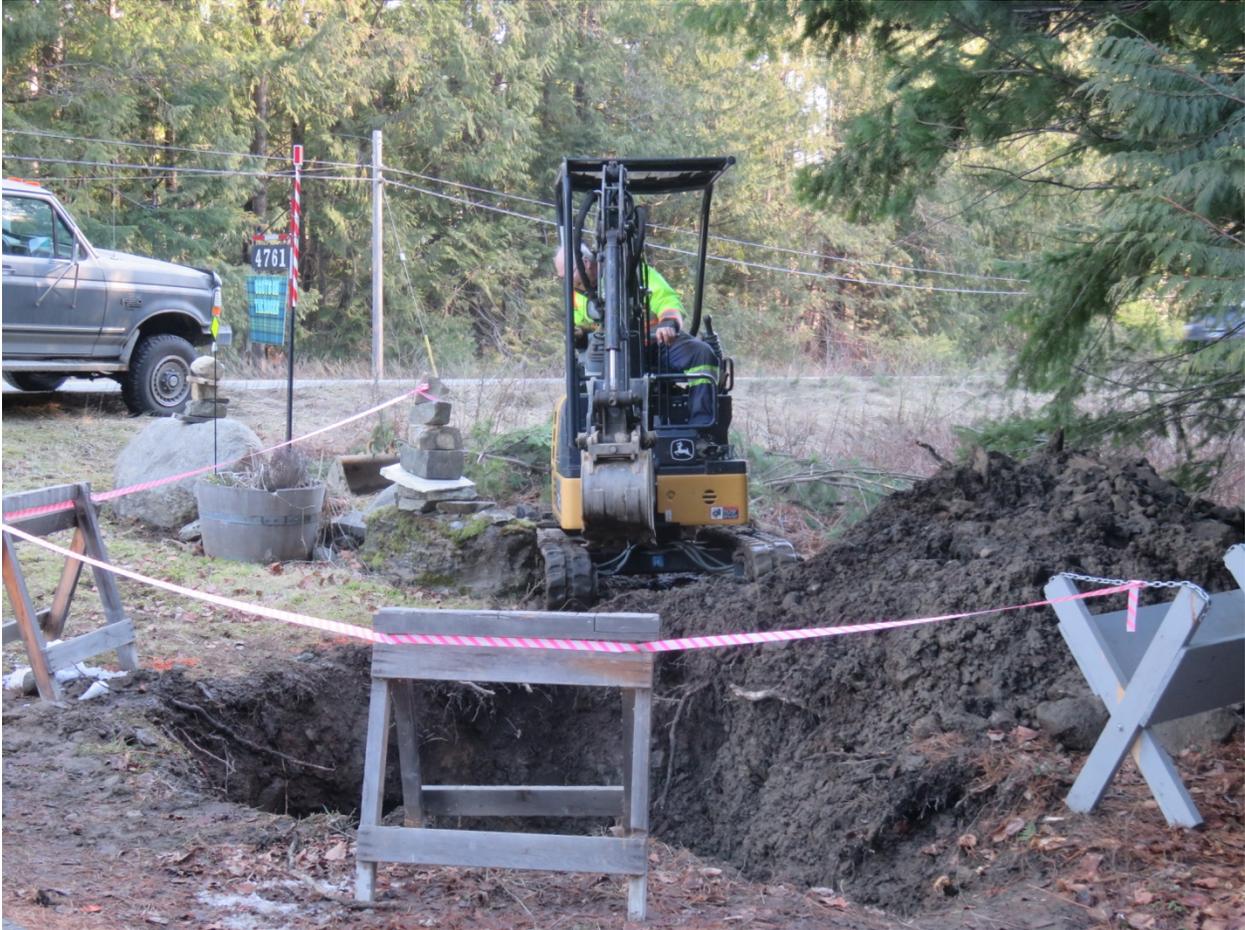
The hole was dry the following morning. All water had seeped away overnight.

- Install a vertical 4" ABS pipe extending from the sleeve to the surface to provide an opportunity to monitor the tightness of the repair.
- Place soft fine material around the pipe and sleeve to protect it from the large sharp rocks.
- Place survey marking ribbon 1 ft above the sleeve as a warning to future excavators.

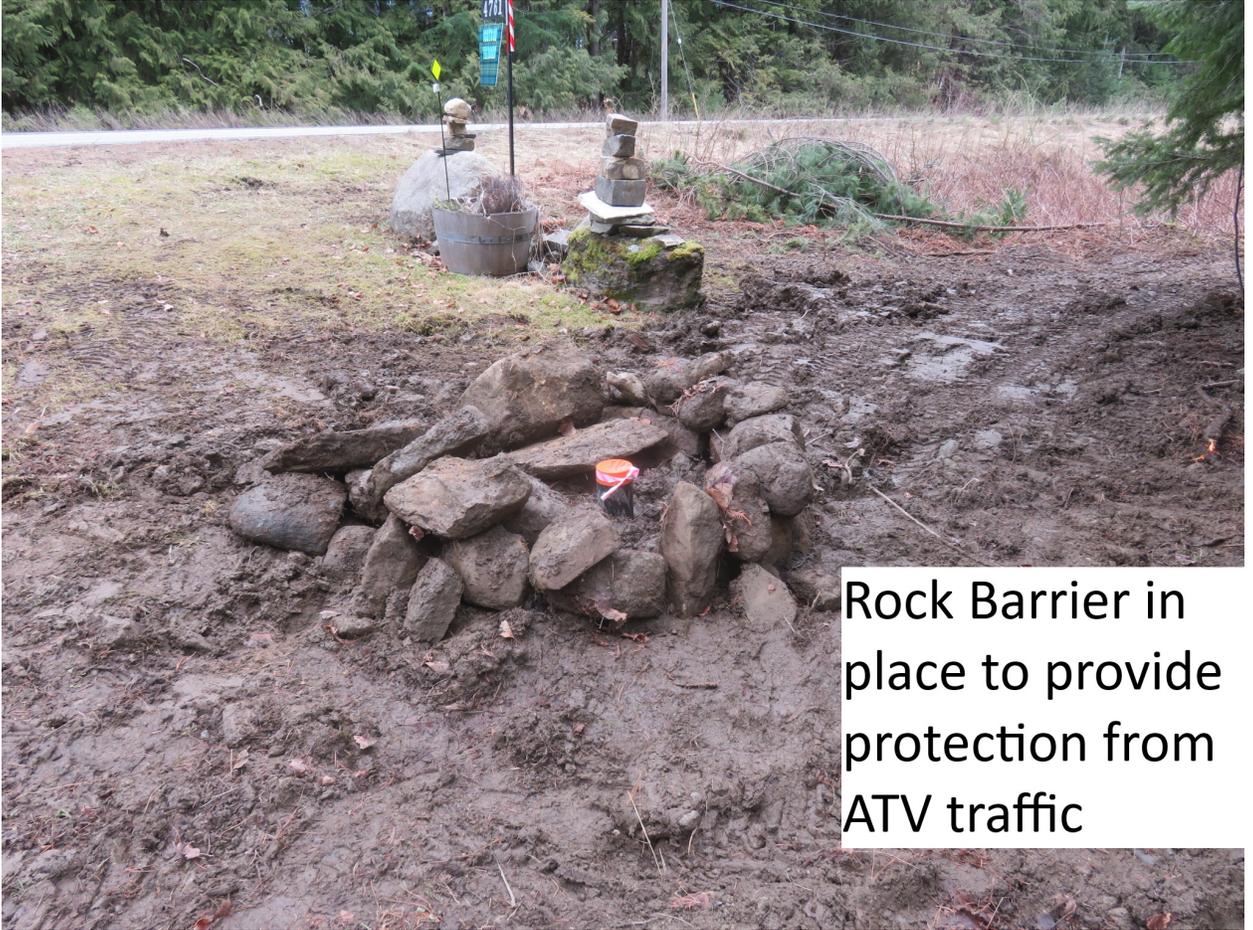
Rock Barrier in place to provide protection from ATV traffic
